Care Home Case Study

Resident Balcony Refurbishment for Sunrise Senior Living

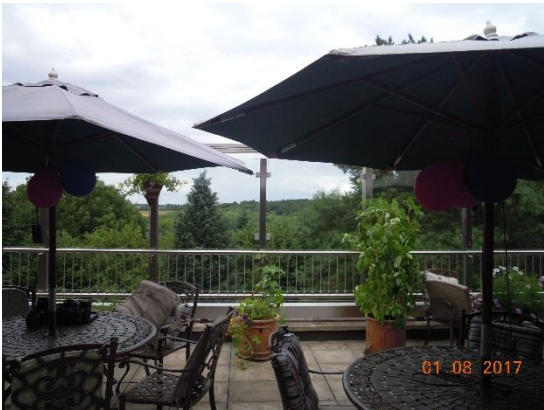
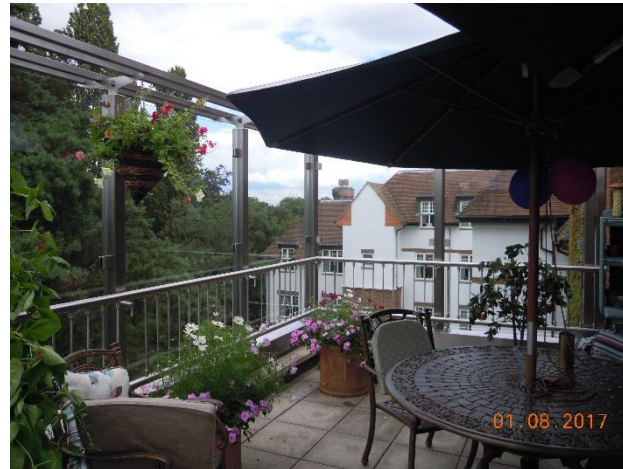
Sunrise Senior Living operate prestigious Care Homes throughout the US and UK. Many of the homes have residential balconies on the upper floors. Traditionally these balconies are constructed using timber fretwork and Perspex which do not survive well in the UK climate and often provide a restricted view. The challenge was to replace this arrangement with one that is long lasting, provides an open aspect and above all is safe for resident use.

An external scaffold platform had to be installed in order to provide a safe working area. The existing wooden structure was removed and the steel upright posts cut down to just above the dwarf wall. A new steel ring-beam was welded onto the upright posts. The new upright chrome posts were then bolted to the ring-beam. Specialist fittings between the posts clamped and supported the laminated glass panes. The high level rails were bolted to the upright posts. Finally the hand rail was fitted to the upright posts. The project was completed in two weeks and was replicated at six sites.

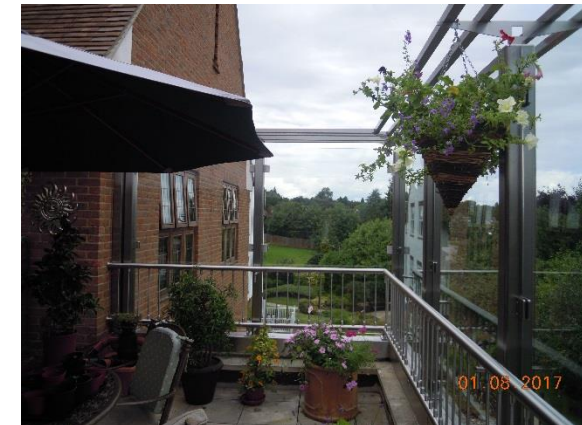
Enertec worked with Veon and Cardell Construction to design a glass and chrome structure which tied into the existing buildings steel structure. A steel ring-beam at low level supported the glass and chrome posts above. Large panes of laminated glass sat between the chrome upright posts. A hand rail runs around the face of the glass for residents to support themselves. The height of the glass was important to make the balcony safe. Four high level horizontal rails run round the top of glass and provide more interest as well as providing additional safety features. Full structural calculates were carried out and the installation was subject to Building Regulations.
